Drawn by	Adam Wechsler	Part N		Qty per glider
Date	20.01.14	Name	Pulley assembly	Rev
Scale	-			2
Approved	Anatoly Cohn

APCO Aviation LTD.

Ball bearing Pulley

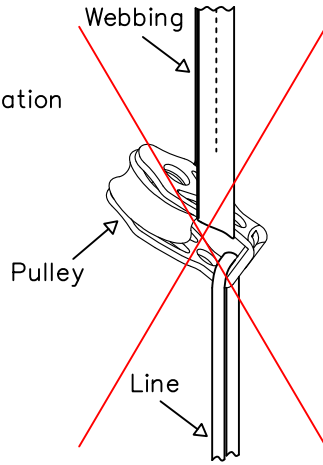
Wrong

Pulley position not secured allowing for line + webbing dislocation

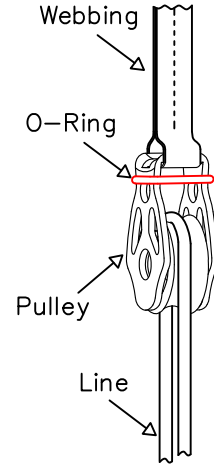
Correct

Pulley position secured by O-Ring

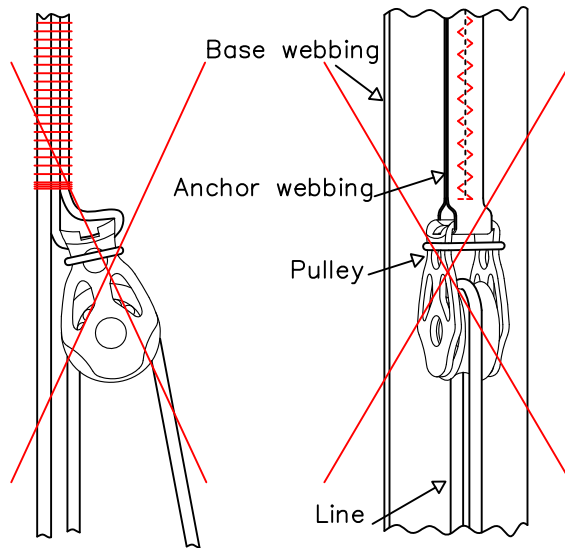
Wrong

Stitching the anchor webbing to the base webbing all the way will fix pulley rigidly preventing flexing on pulley to follow the line direction.

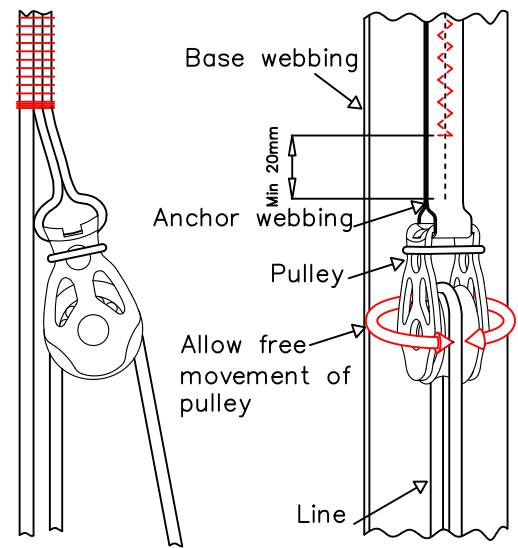
Correct

Do not stitch the anchor webbing to the base webbing all the way. Leave minimum 20mm-30mm free to allow twisting of pulley to follow the line direction.
